CONTINENTAL MOTORS® AIRCRAFT ENGINE
SERVICE INFORMATION DIRECTIVE

CATEGORY 4
SID05-1B

SUBJECT: Inspection Guidelines for CM Camshafts and Hydraulic Lifters

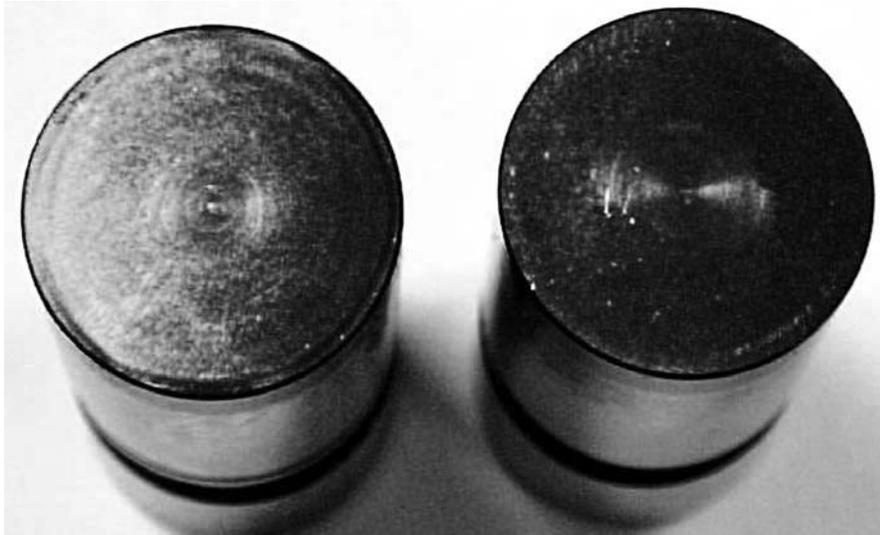
The interface between a cam lobe and lifter will experience normal wear as the engine operates. Normal wear may take the form of a bright shiny uniform wear surface, with a circular pattern visible on the lifter face. Minimal “wear material” will be collected by the oil and trapped in the oil filter element or screen. Localized areas may show minor signs of galling or spalling under normal service due to various operating conditions.

Figure 4. Typical Lifter Faces from Service

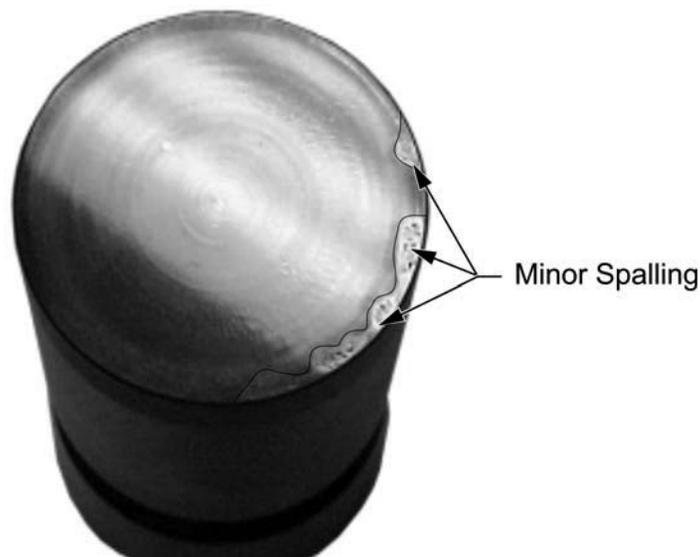
Normal minor spalling caused from corrosion or other factors will not affect operation as the loads are redistributed to the surrounding material. Minor spalling will appear as separated spalled areas with polished contact patterns on the remainder of the face (see Figure 5).

Figure 5. Indications of Minor Spalling

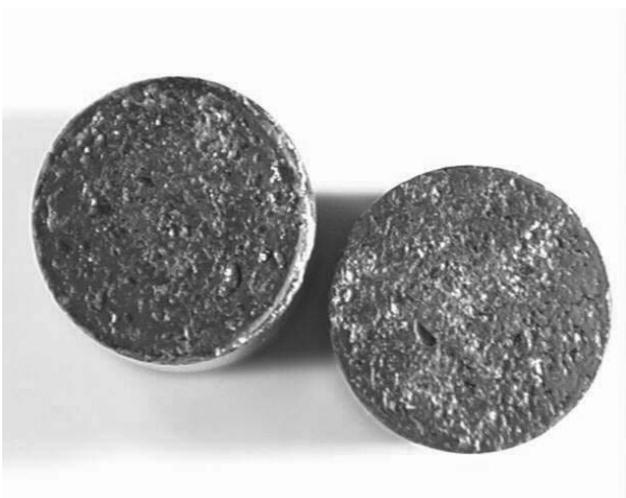
Major spalling that involves much of the face will usually have no effect on operation and will frequently “heal over”; reestablishing a stable surface for the cam interface. The short-term effect on the cam is generally insignificant. The discarded material from spalling will be minimal and deposit in the filter element or screen.

Figure 6. Full Face Spalling

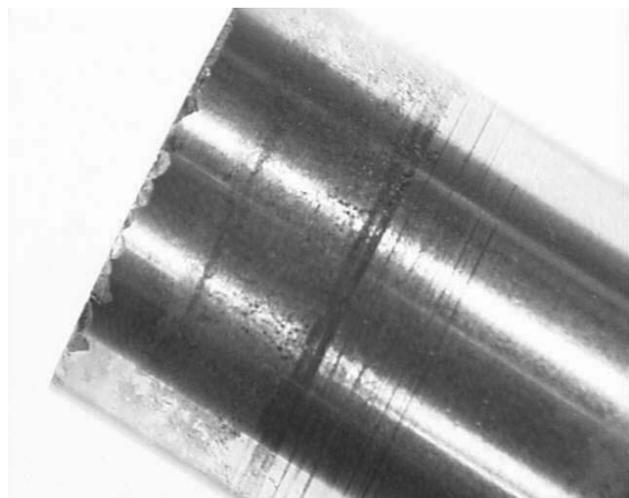
Spall wear initially appears in small areas on the lifter face that have begun to separate, leaving shallow pits. Because the camshaft is constructed from steel and the lifter body from iron; rust and corrosion are the most common cause of spalling.

Figure 7. Corrosion Etching On Lifter Body

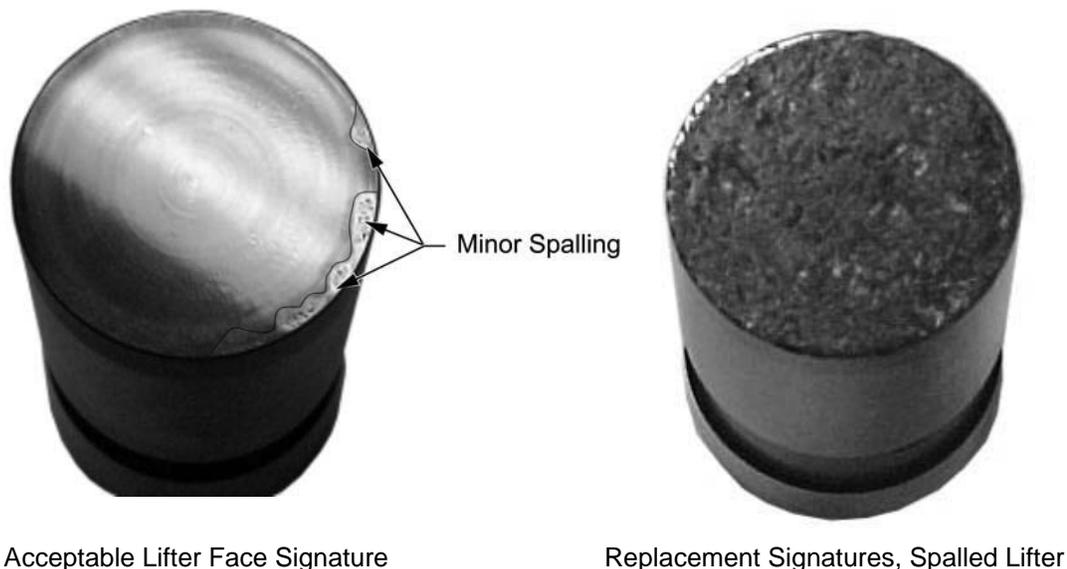
Figure 8. Example Replacement Signature, Hydraulic Lifter

3. Inspect and replace lifters with severe face or lifter body wear signatures or spalling that exceeds 10% of the surface area. Lifters associated with noise indicating excessive valve lash should also be replaced regardless of face condition.

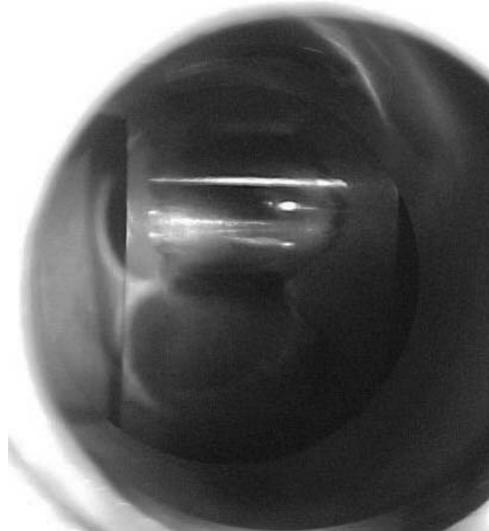
Normal Wear Signature Shown

Figure 9. Cam Lobe Apex in Inspection Location

5. Turn engine so that the apex of the cam lobe is visible through the lifter bore in the crankcase (see Figure 9).
6. Perform visual inspection of cam lobe using an inspection light.
7. Repeat Steps 5 and 6 to examine all camshaft lobes.
 - a. If the surface is smooth and shiny with only small areas of rough appearance, *no further action is required.*

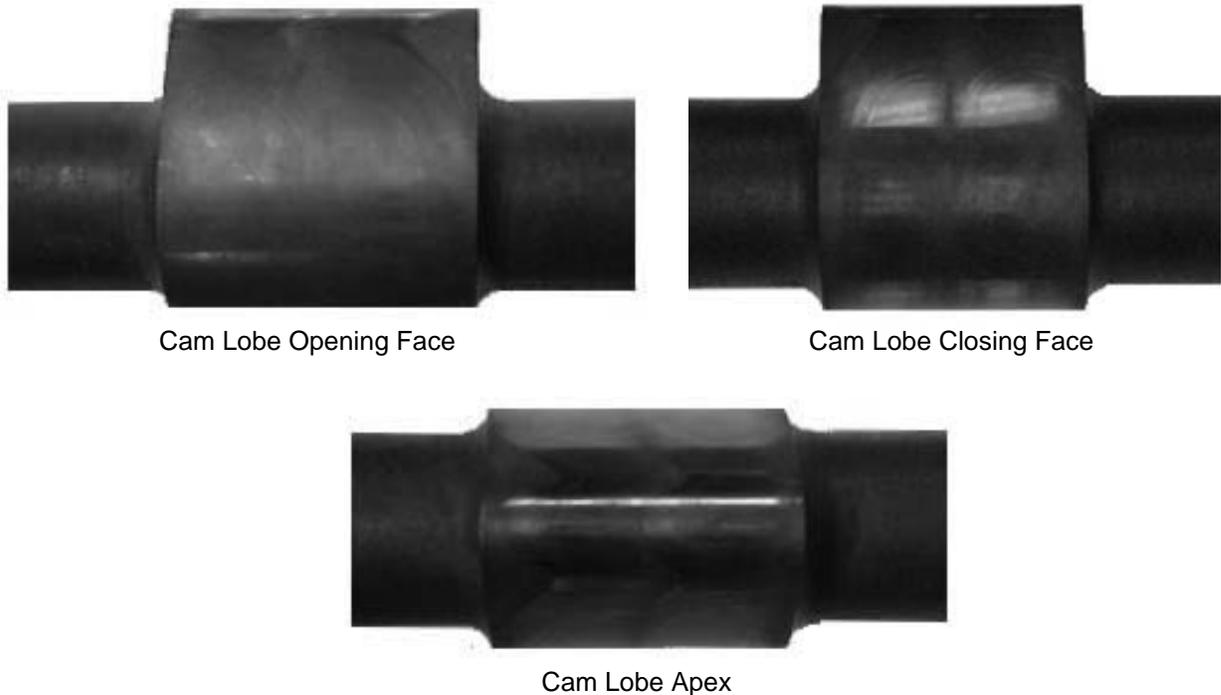
Figure 10. Typical Cam Lobe Wear Signatures

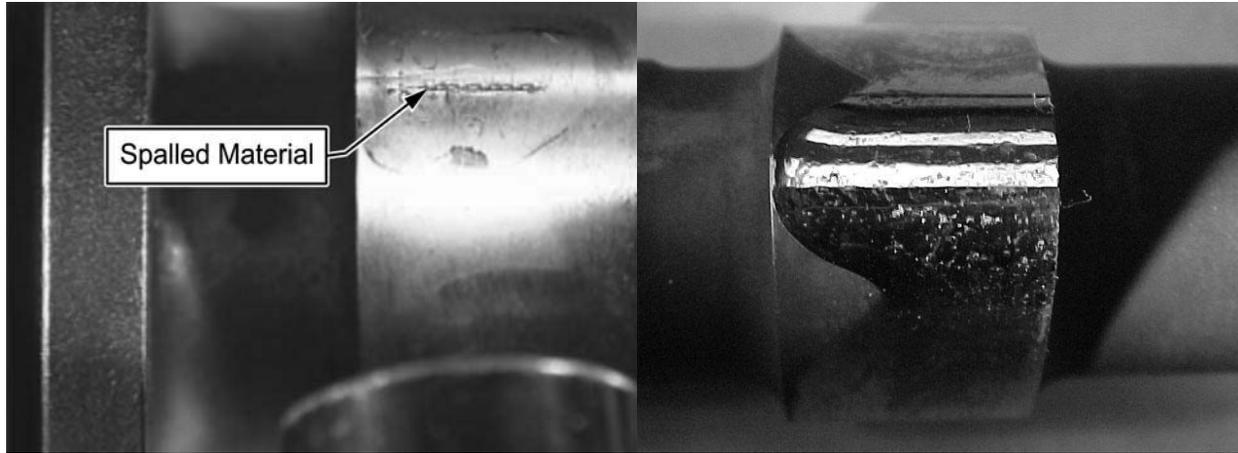
In some cases, significant spalling may result in some damage to the cam lobe apex. This level of damage is very rare, but will manifest itself as surface cracks on the nose with moderate depth. Corrosion/rust will also cause cam lobe distress. See steps 5 through 8, “Perform visual inspection of cam lobe using an inspection light.” on page 8. for detailed information.

Spalled Cam Lobe

Corrosion Pitted Cam Lobe

Figure 11. Suspect Cam Lobe Wear Signatures

8. If the visual cam lobe inspection reveals the presence of indentions or crack like features in the surface along the cam lobe apex, use a sharp pick or awl and lightly move it's tip over the suspect surface area. If the suspect feature has any depth, the pick tip will repeatedly catch in the groove or pits.
 - 1) If the indentation or crack is determined to have depth, the cam must be examined by a CM service representative to determine any additional steps required.

For minor distress, the camshaft may be continued in service and re-examined upon the accumulation of 100 hours operation or 12 months, whichever occurs first. If the CM representative determines the camshaft should be replaced, the engine should be removed for repair.
