Continental Motors® PMA Aircraft Engine Products
SERVICE INFORMATION LETTER

CATEGORY 5
SIL011

SUBJECT: Replacement PMA Crankcases, (P/N AEL65460)

PURPOSE: To provide installation eligibility, procedures, and specifications for adding oil drain provisions when using a solid or hollow main journal that does not have a pierced rear oil plug.

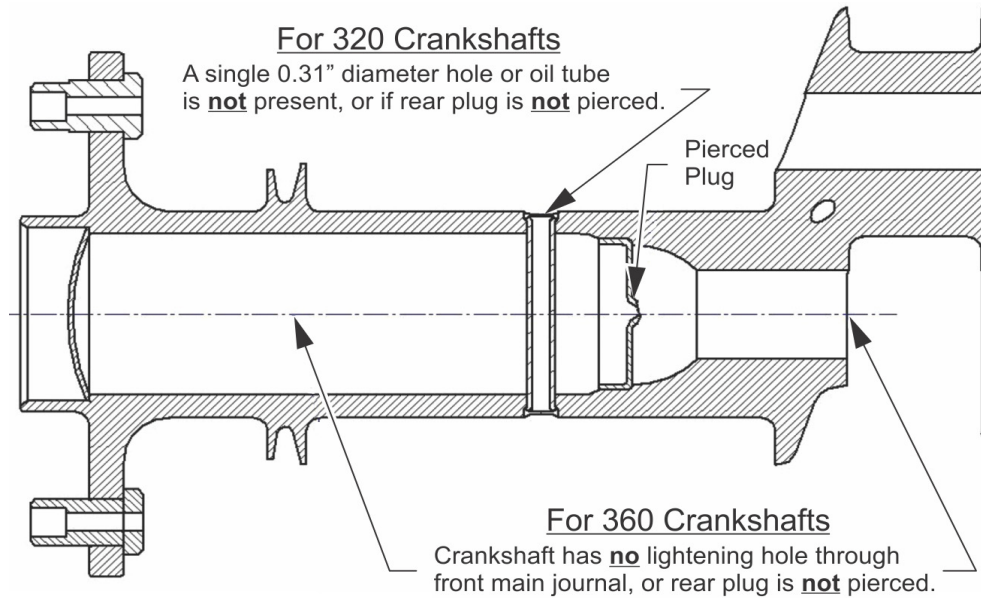
Figure 1. Crankshaft Applicability (per Lycoming® Service Instruction SI1435)

Oil from the bearing is normally drained through a radial tube in the crankshaft main bearing, and then, through the crankshaft front main bearing journal lightening hole into the crankcase interior (see Figure 1).

“Solid” crankshafts have no drain hole, oil tube, pierced rear plug, or lightening hole through the front main journal ID (per Lycoming® Service Instruction, SI1435).

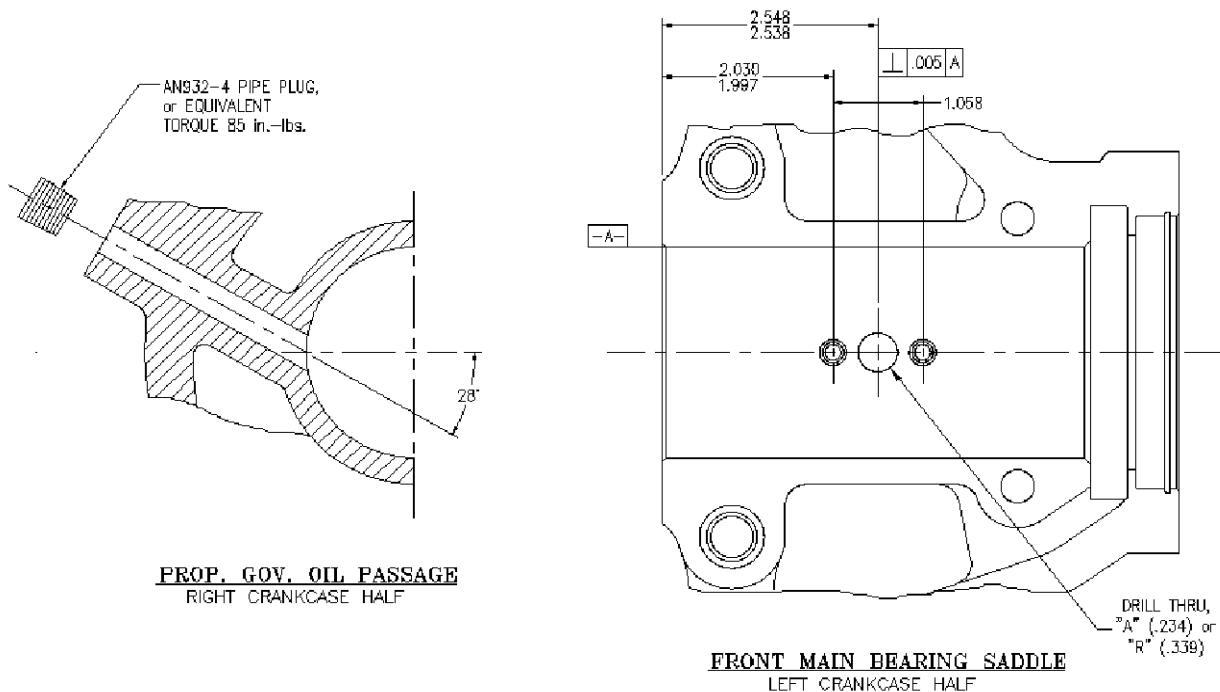
Figure 2. Crankcase Oil Drain Provision (fixed pitch operation)

If the crankshaft does not have oil drain provisions (no lightening hole), or if an unpierced rear plug is installed, a provision must be machined to drain oil flow into the crankcase interior by drilling a single hole between the bearing dowels in the front main bearing saddle of the left crankcase half (see Figure 2, 2-4 cylinder side).

2. If the crankshaft has no oil drain provision as described above, this provision must be added to the crankcase by drilling a single drain hole in the left crankcase half (2-4 cylinder side), as described in the following instructions:
 - a. Mount the left crankcase half securely on the table of a suitable drill press or vertical milling machine in order to ensure accurate positioning and perpendicularity.
 - b. Drill a hole 0.005-0.015 inch (drilled as shown Figure 2) and de-burr the edges. Thoroughly inspect the crankcase to ensure that all metal chips have been removed.

- c. Install an AN932-4 steel plug in the right crankcase half using Loctite 592 pipe sealant and torque to 85 in-lbs.
- d. Enter the following statement in appropriate engine maintenance logbook:
"Drilled oil drain hole in left crankcase half and installed plug in right crankcase half per Continental Motors SIL011."

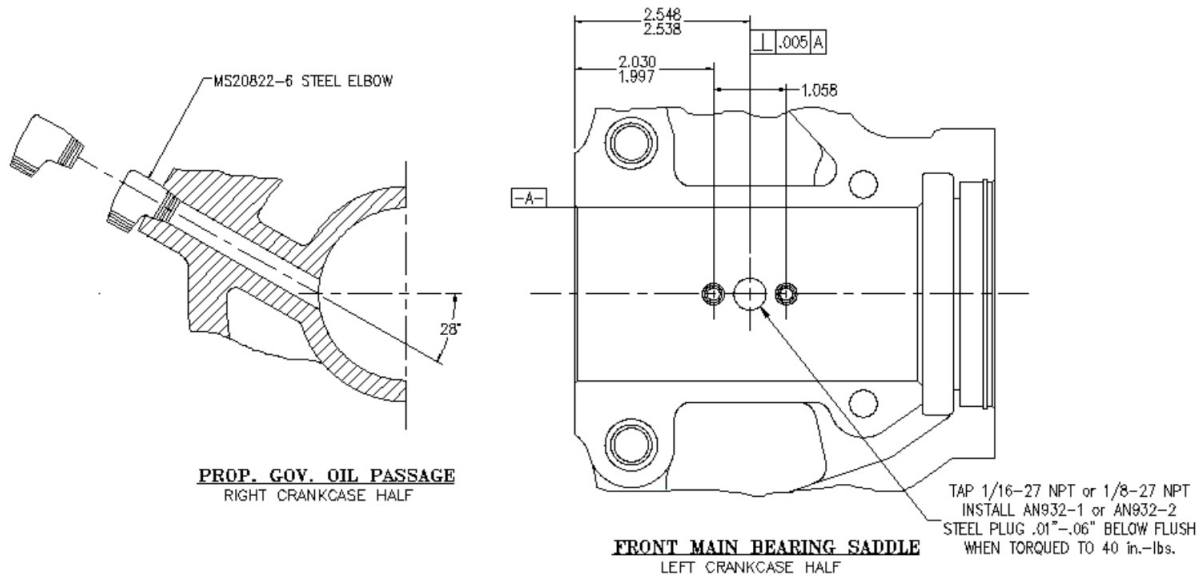
Figure 3. Crankcase Oil Drain Provision (constant pitch operation)

Crankcases reworked in accordance with this Service Document may subsequently be converted for operation with constant speed propellers, if desired, by exchanging crankshaft and reconfiguration of the crankcase oil passages in accordance with Figure 3. Proceed as follows:

2. Tap threads in the drain hole of the left crankcase half. If the hole is 0.234", use a 1/16-27 NPT tap. If the hole is 0.339", use a 1/8-27 NPT tap.

4. Position the plug to be installed in the tapped hole. If tap is 1/16-27 NPT, use AN932-1 steel plug. If tap is 1/8-27 NPT, use AN932-2 steel plug.

7. Remove the AN932-4 steel plug from the governor oil passage in the right crankcase half and install MS20822-6 steel elbow using Loctite 592 pipe sealant sparingly on the threads and torque to 85 in-lbs.

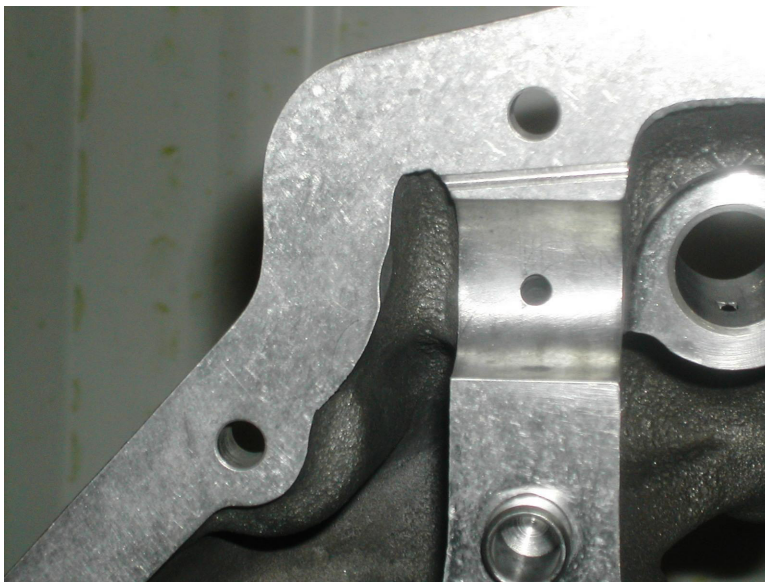
Figure 4. Anti-Wicking Groove (Front Cam Bearing Boss), *typical*

Reference Figures 4 and 5 for typical locations of machined anti-wicking grooves on Lycoming® engines.

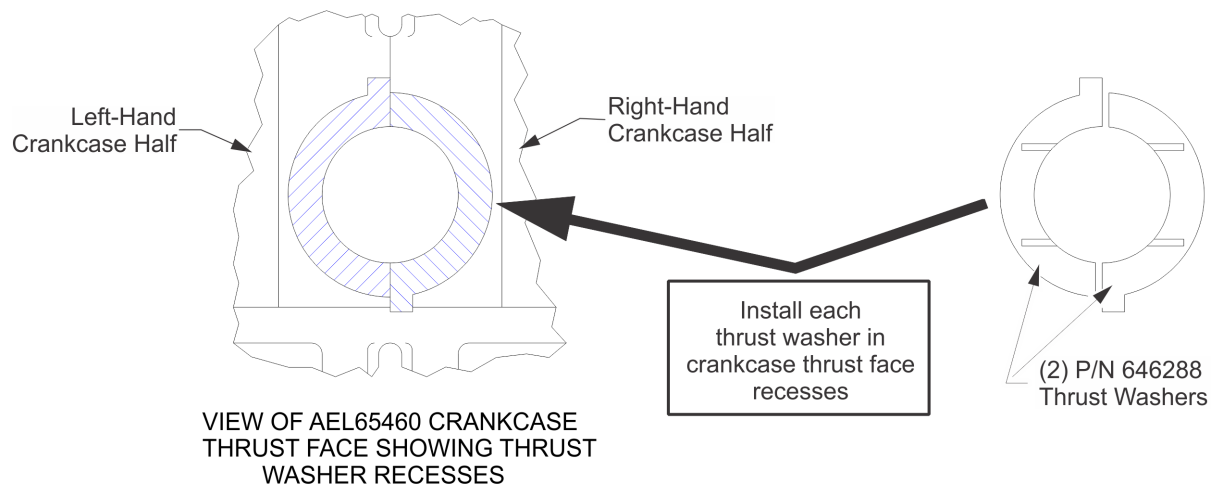
Figure 7. Crankcase with Thrust Washer Modification

Crankcases with thrust washer modification (AEL65460-04 and AEL65460-12), must have P/N 646288 (or equivalent approved replacement) installed in order to meet clearance requirements. The thrust washer design also helps to reduce wear directly on the crankcase thrust face surface and helps reduce costs at overhaul.

Thrust washers shall be installed with the scallops/oil relief grooves facing towards the crankshaft (reference Figure 6 and Figure 7).
