CONTINENTAL MOTORS® AIRCRAFT ENGINE
SERVICE INFORMATION DIRECTIVE

CATEGORY 4
SID05-1B

SUBJECT: Inspection Guidelines for CM Camshafts and Hydraulic Lifters

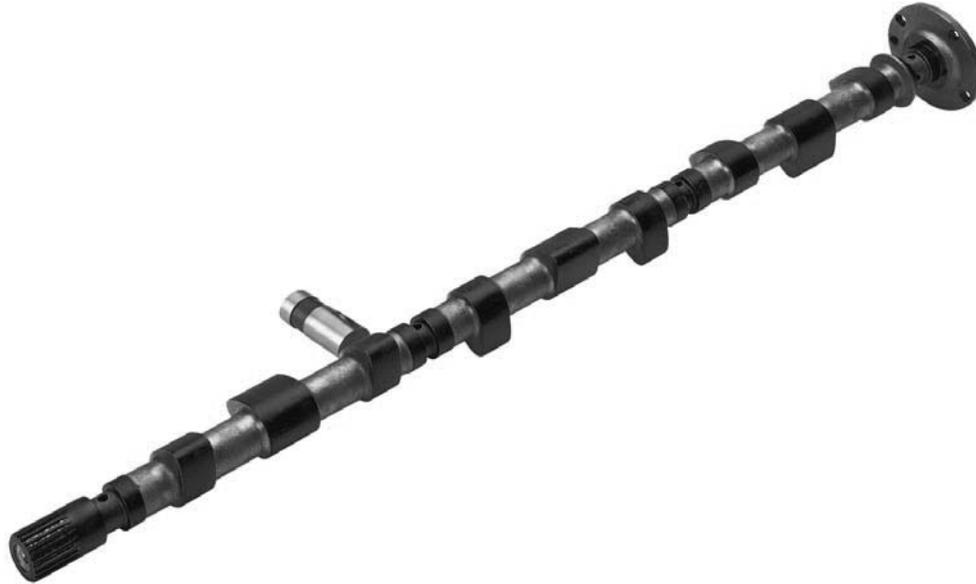
Figure 3. Camshaft and Lifter Interface, typical

The material of the camshaft is aircraft quality steel with the cam lobes treated by carburizing for additional hardness and wear resistance. The lifter body is made of cast iron with the face being “chilled” during casting to provide an extremely hard wear-resistant material. During manufacture, the lifter face and cam lobes are also coated with a manganese phosphate coating to resist rust and lower friction during the initial hours of engine operation (see Figure 3).
